ARMOREDTM
HOME INSPECTIONS, LLC

**06/03/09 INSPECTION REPORT FOR:
600 YOUR STREET, ANYTOWN, PA 19999**

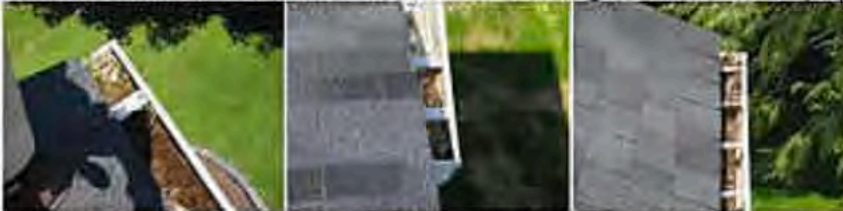
13. Marginal

Gutters: Aluminum- Debris filled and blocked. Cleaning recommended for proper roof drainage.

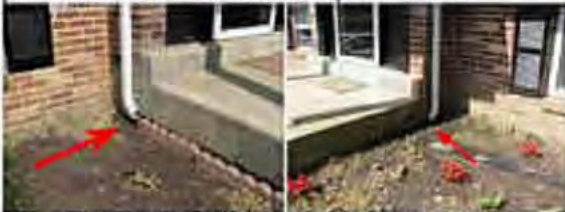
14. Marginal

Downspouts: Aluminum- Extension at downspout termination points are recommended to prevent water penetration in basement/crawlspace areas.

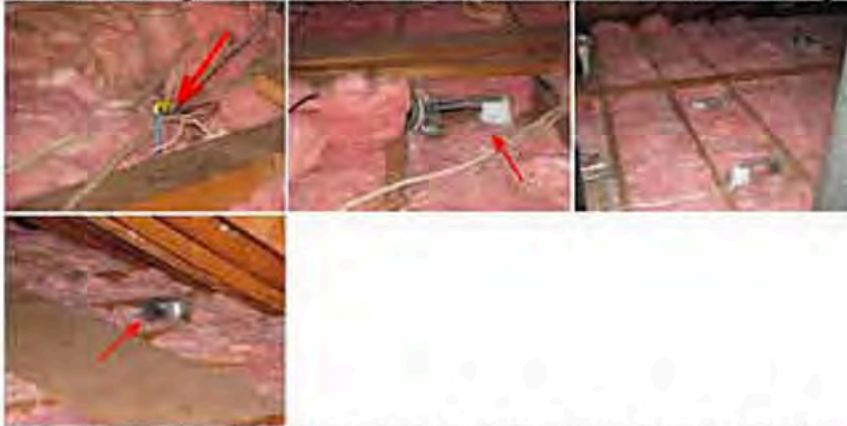
11. Marginal **Wiring/Lighting: 110 VAC lighting circuit- 1.Exposed wiring splices noted in attic. Proper wiring connection in proper box recommended. 2.Recessed lighting fixtures in contact with insulation. This poses a fire safety concern. Blocking installation to prevent insulation contact with fixture housings is recommended.**

<u>Low</u>	<u>High</u>
<u>Garage/Carport</u>		
Ceiling: Duct insulation and ceiling repair	\$ 200	\$ 400
<u>Attic</u>		
Wiring/Lighting: Blocking/insulation stops at light fixture housing	\$ 200	\$ 300
Bathroom Fan Venting: Routing exhaust to exterior	\$ 150	\$ 200
<u>Bathroom</u>		
Toilets: Toilet repair/securing	\$ 75	\$ 150
<u>Kitchen</u>		
Dishwasher: Dishwasher replacement	\$ 150	\$ 450
Microwave: Hard wiring installation for unit and securing	\$ 250	\$ 400
Electrical: GFCI receptacle/circuit installation	\$ 150	\$ 200
Repair Total	\$ 1175	\$ 2100

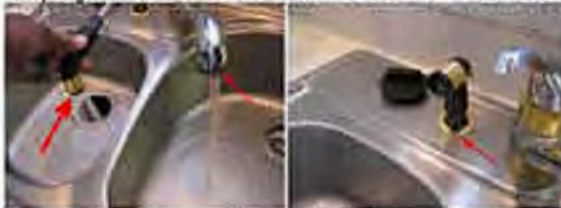
8. Marginal **Sink:** Dual bowl stainless- 1.Spray permits water at spout when in use, repair/replacement recommended.
2.Spray wand also leaks after use into cabinet below, repair/replacement recommended.

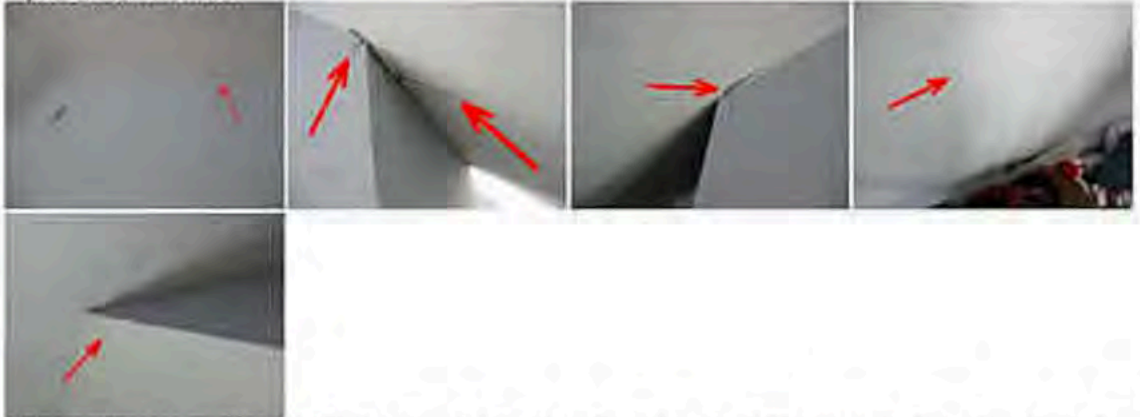
18. Marginal **Ceiling:** Painted wallboard- Evidence of past or present water leakage, roof evaluation/repairs and cosmetic repairs recommended.

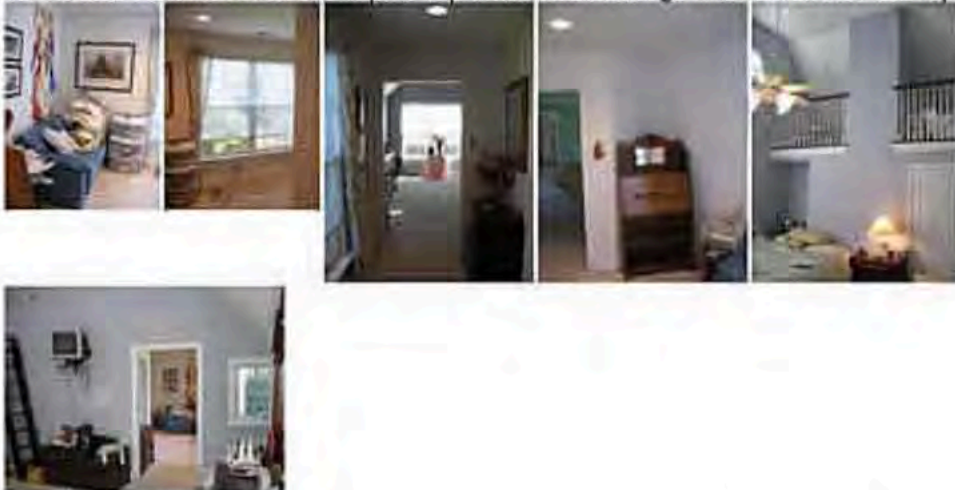
19. Marginal **Walls:** Painted wallboard- Cracks observed. These are common in plaster/gypsum walls and ceilings and are considered cosmetic. Evidence of past or present water leakage in loft area. cosmetic repairs recommended.

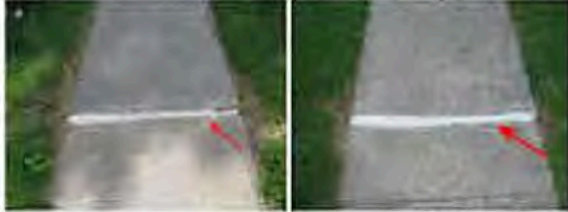
1. **Walks: Concrete- Uneven pavement** may result in a hazard at front, pad leveling/replacement recommended.

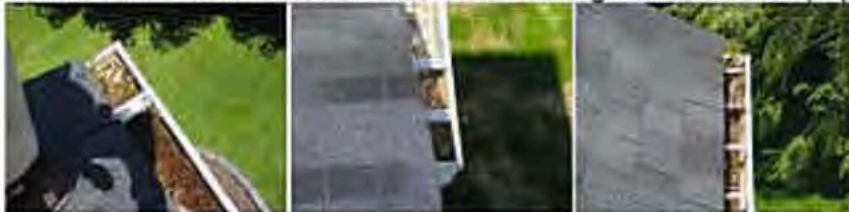
4. **Gutters: Aluminum- Debris filled and blocked.** Cleaning recommended for proper roof drainage.

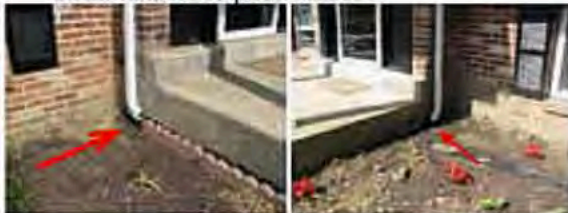
5. **Downspouts: Aluminum- Extension at downspout termination points** are recommended to prevent water penetration in basement/crawlspace areas.
