ARMOREDTM
HOME INSPECTIONS, LLC

**06/03/09 INSPECTION REPORT FOR:
600 YOUR STREET, ANYTOWN, PA 19999**

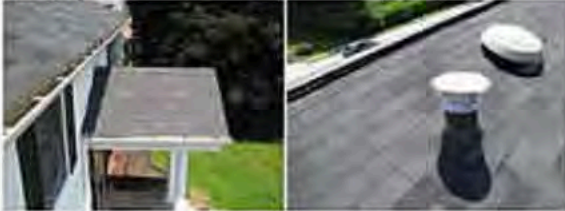
7. Type: Gable

8. Approx Age: 1-3

9. Not Inspected Flashing: None visible- Flashing covered by exterior wall covering. Not visible for identification or inspection.

10. Acceptable Valleys: Asphalt shingle

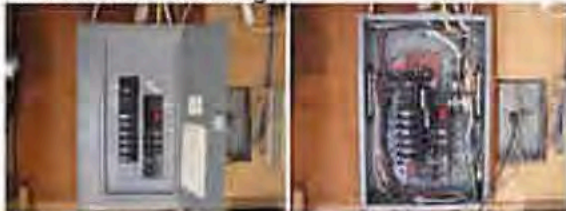
Garage Electric Panel

8. Acceptable Manufacturer: Challenger

9. Max Capacity: 100 Amps

10. Acceptable Main Breaker Size: 100 Amps

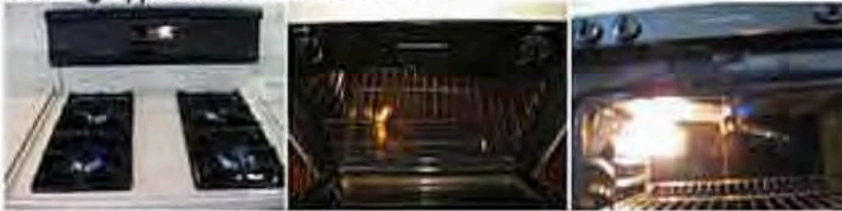
Main floor Kitchen

1. Acceptable **Cooking Appliances:** General Electric

2. Acceptable **Ventilator:** General Electric

3. Acceptable **Disposal:** General Electric
